VOLUME 3 NUMBER 12

AUGUST 2004

BOAT DECK FAILURES

MORE AND MORE DECKS ON SPORT FISHING BOATS ARE FAILING...WHY?

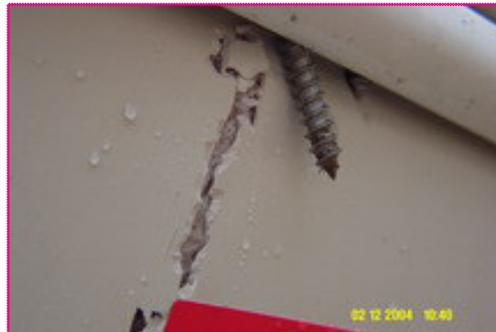
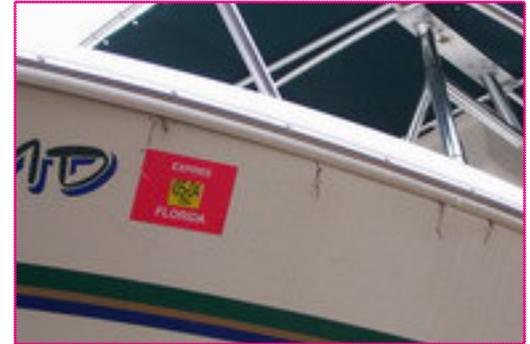
wind and the size of the waves when the boat impacts the water. Imagine holding your hand outside an automobile window with the palm facing the wind at 30 or 40 miles per hour and feeling the effects and required strength. A typical hand is about 5 inches by 7 inches in diameter. Now consider the push and pull force that is generated by a T-top that is maybe 5 feet by 7 feet in diameter, or larger. The deck is subjected to the push and pull that is transferred to the attached stringers and where the hull is attached, much like an accordion effect. There will also be evidence of spider cracking on the fiberglass deck at the flex areas. In those areas, the stringers are most likely damaged or broken.

Usually the first indication there is a failure is a deck/hull separation. Screws will be present outside the hull and a scraping of the screw threads will be visible against the fiberglass. The deck/hull joint will

be open and out of place. This can be a serious situation for the boater depending on where the boat is and the weather conditions. What the boater has is two halves of a boat that has lost a substantial amount of structural strength with the potential to take on water. The deck is essentially flapping up and down on the hull.
