VOLUME 3 NUMBER 9

MAY 2004

FLOOR TILE FAILURES

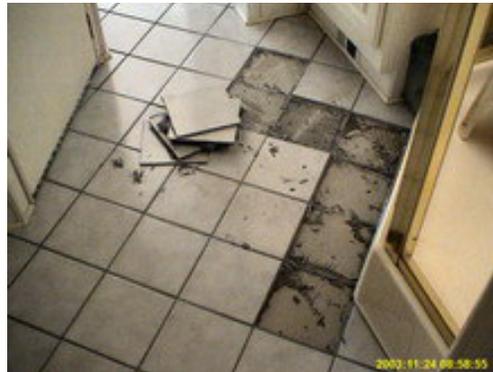
RV floor tile problems can originate from many sources. First let's examine how it is originally installed and what happens over time. RV sub-floors are generally of plywood or pressed wood particles and attached to the frame cross supports by bolts or screws. In some motor homes, the floor is raised above the body framework, allowing storage below. A tile adhesive is applied to the sub-floor and the tile laid in place. The adhesive is water repellent and forms a protective barrier between the tile and sub-floor. After the tile has set, grout is applied between the tiles, and then smoothed to make a finished floor. Now that we know how a floor is installed let's look at what happens to the floor between the time the owner purchases the RV and when the failure occurs. On the highway an RV experiences flexing of the entire body. The body is not rigid and the degree of flex depends on the loads imposed. If an owner subjects the RV to it's maximum gross weight and then to poor or bad highway conditions, the normal design flex can be exceeded,

thus causing not only floor cracking but also joint adhesive failures in the roof and sidewalls. When the body flexes, the floor has a degree of twist, which in turn can cause the grout between the tiles to crack. After a period of time the grout can disintegrate leaving a wider crack and that is when everyone starts pointing fingers.

So what is the solution? If you are an insurance company, don't listen to a repair facility for the truth, they have their own agenda and that is making money. Have an experienced RV investigator examine the RV and if it is not an impact issue or does not fall within the policy provisions, deny the claim. If you are a manufacturer, ascertain what exactly caused the failure and then educate the owner on how floors are installed and why your installation did not fail. Rarely do manufacturer's floors fail due to manufacturing negligence. If you find no evidence of a failed installation and the owner does not accept your finding, then you may have to seek an independent source to ascertain if the RV exceeded the design limitations.
